Evaluation of the remaining lifetime of the piers of the railway bridge crossing the Little Belt, Denmark

Summary

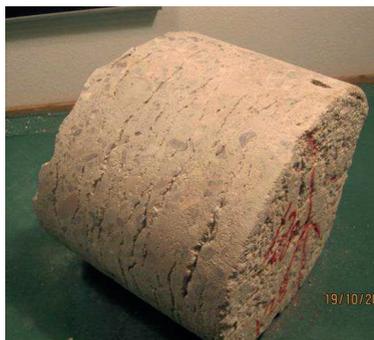
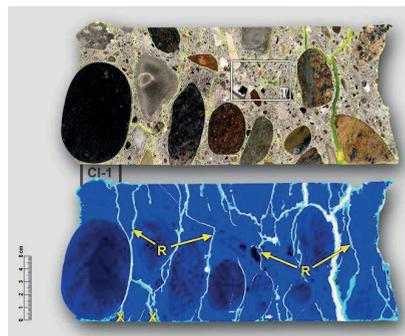
The preliminary investigations of the 4 main concrete piers situated in seawater indicated that severe degradation of the concrete was occurring. A detailed investigation of the concrete in the piers confirmed extensive cracking due to mixed design of the concrete made with reactive aggregates from a local source.

Fig. 2: Sample and test results from the mass concrete near the inner side, showing that the cracks are mainly vertical.

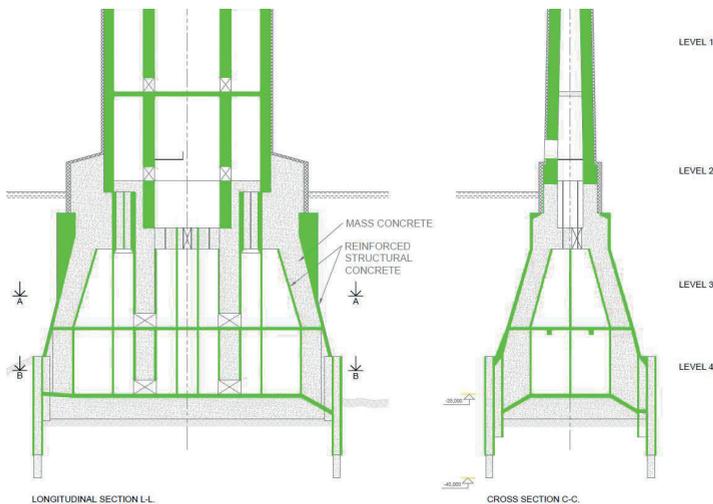
Fig. 3: Vertical sections of the piers. The reinforced concrete is high-lighted in green signature, and the mass concrete are marked in grey. The inner parts of the piers are hollow, thus making it possible to inspect the internal sections of the piers from top to bottom.

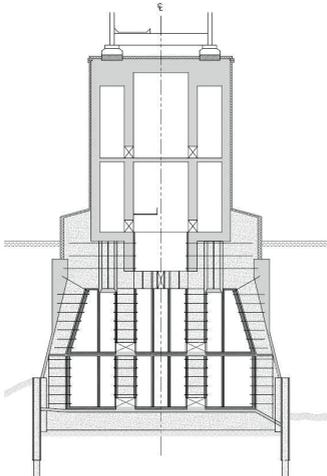
Fig. 4: Rehabilitation of the pillar includes construction of new reinforced concrete walls on the internal sides of the walls to be attached to the existing structures with anchors through the mass concrete.

New reinforced concrete walls to be constructed on the internal sides of the existing walls in the cells at the lower level (level 3 and 4). The new walls shall be designed to take over the load bearing capacity from the existing structure, leaving the existing structure to disintegrate due to the alkali-silica-reactions.

The concrete in the existing walls will be kept in place with numerous long anchors, drilled through the mass concrete and anchored into the new walls.

New reinforced concrete slabs in the lower level and between the levels will be constructed in order to replace the existing deck slabs, which will provide the stability of the piers.

If the disintegration of the outside walls is deemed beyond acceptable, an intermediate sheet pile wall will be constructed, surrounding the pillar. Behind the sheet pile wall, a reinforced concrete wall will be constructed on the outside of the existing structure. The new external concrete wall will be connected to the new internal concrete wall with anchors through the mass concrete.
