Inspection and Retrofitting of Fatigue Damaged Orthotropic Steel Deck

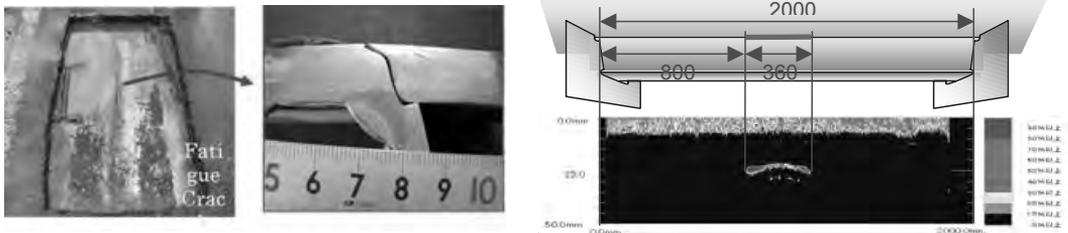
measured by wired-encoder. Recorded data will be displayed on real time B scope view (*Fig.2*).

Forty spans of orthotropic girder have been inspected with SAUT and 130 longitudinal cracks have been detected since the inspection started in January 2007. Most of cracks are shorter than 50mm, but 20 cracks exceed 100mm and stop hole penetrating U rib and deck plate has been drilled as counter measurement for these cracks.

Fig.2 SAUT result (B scope view)

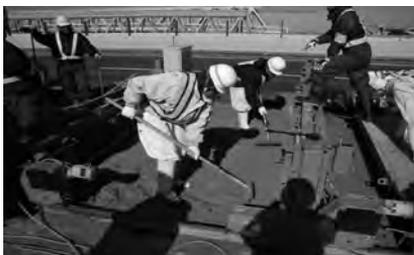
Fig.3 SFRC Placemen

Temporary counter measurement due to stop hole and cover plate is not sufficient to reduce stress range in OSD. There were cases where fatigue cracks initiated again after the temporary retrofitting. Undergoing retrofitting is the replacement of damaged U rib and placement of Steel Fiber Reinforced Concrete (SFRC) in 50 mm thickness on the deck plate in order to increase the stiffness of the deck plate (*Fig.3*). If the crack is longer than 300mm, longitudinal U rib is replaced and SFRC is placed on the damaged deck after that. Stress ranges in the retrofitted OSD, is less than one eighth of OSD, without the retrofitting.
