Union Depot: Assessment of Historic Concrete and Timber Pile Structures

Rehabilitation of the historic Union Depot railroad terminal in St. Paul, Minnesota, USA hinged on whether the 90-year-old structure, which exhibited widespread and locally severe deterioration, had sufficient remaining capacity or could be effectively and practically repaired to support the anticipated loads of the rehabilitated facility. The unique approach used to assess the concrete superstructure and timber pile foundations of this very large facility, which relied on comprehensive field inspections followed by targeted testing and structural analysis, allowed most of the original structure to be salvaged and effectively repaired for the desired service life of 50 years.

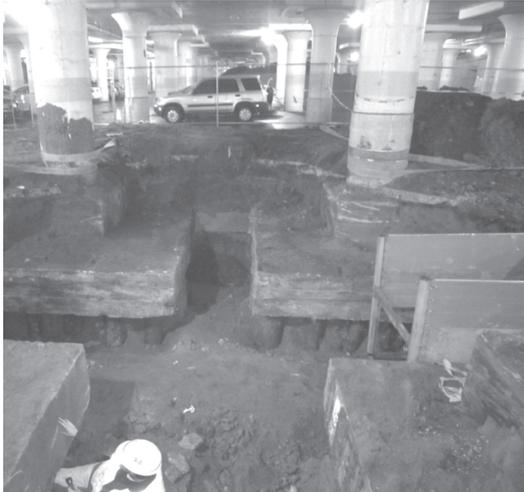
of pile degradation, strategically located test pits (Figure 2) and direct examination of 54 piles, field and laboratory load testing of full pile sections (both intact and partially cut), and innovative statistical analysis to predict future reliability of the timber pile group.

Figure 2. Test pit with exposed pile caps and timber piles

It was concluded that the timber pile foundations supporting the southern portion of the track deck should not be relied upon to support the heavy rail loads proposed for that portion of the facility.

Underpinning or foundation replacement were recommended for that area. For the northern two-thirds of the track deck, where the pile conditions were better and the loads lighter, it was concluded that the existing foundations should have sufficient capacity to support the anticipated load and vehicle loads for the next 50 years, although there is a relatively low risk of localized foundation settlement that may need to be remedied should it occur.

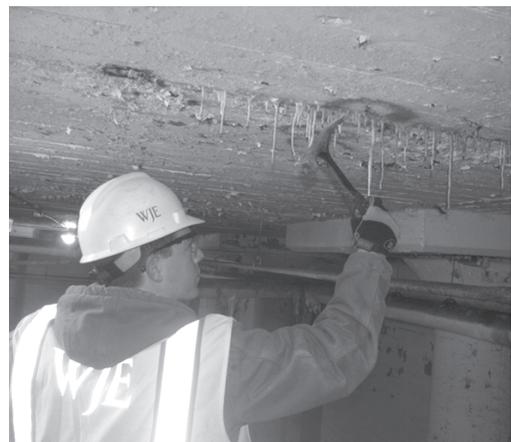
The concrete superstructure was assessed through a combination of field observations, laboratory testing, and structural analysis. The concrete superstructure exhibited significant deterioration (Figure 3) in varying degrees, including cracks, delaminations and spalling, exposed and corroded reinforcing steel, water leakage, cyclic freezing and thawing, and corrosion from deicing salts were identified as the primary causes of deterioration.

Figure 3. Efflorescence, leakage and deterioration of concrete along construction joint in track deck

A comprehensive rehabilitation program that included partial depth and localized full-depth repairs, galvanic cathodic protection for corrosion mitigation, new deck waterproofing, and improved deck drainage was developed to restore deteriorated areas and enhance long-term durability to meet the desired 50-year service life extension.
