IABSE Bulletins

Case Studies

Man-Chung Tang

The Story of the Koror Bridge

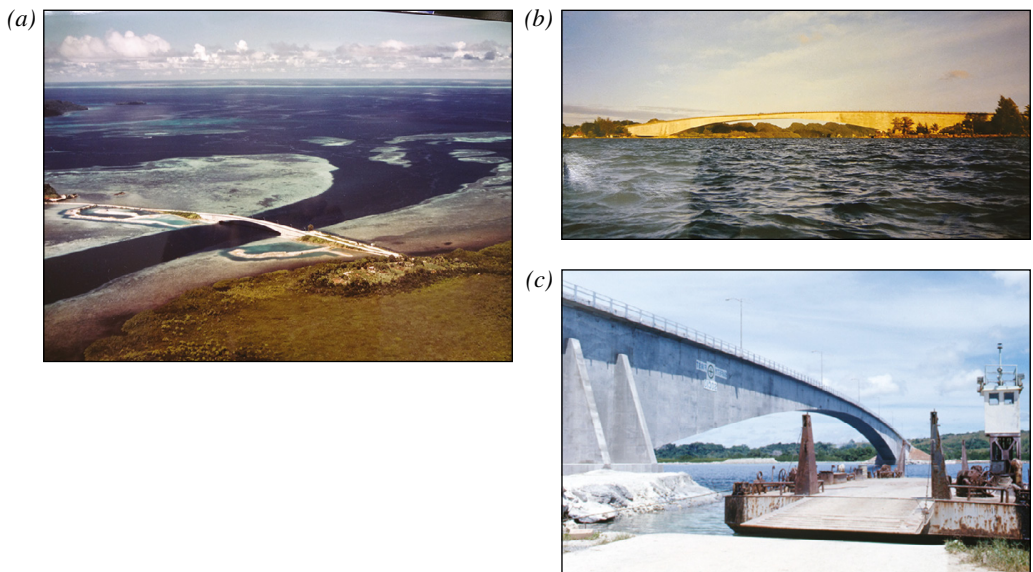
Fig. 18: Koror Bridge and its surrounding landscape: (a) The completed Bridge; (b) Bridge May 1986; (c) Bridge and the Ferry it replaced

The elastic deflection at the span centre under total permanent load after 10% prestress loss was 370 mm. When this is multiplied by the creep coefficient of 1.30, this resulted in a creep deflection of 481 mm after completion of the bridge. *Figure 19* shows the time function of creep progress according to CEB-FIP 1970. It demonstrated that most creep deformation should have been completed around 1000 days after load application, and the progression of creep should be as shown in *Fig. 10*. However the reality is quite different from the calculation.
