REPAIR PROJECT OF A VEHICULAR BRIDGE DAMAGED DURING THE 2017 PUEBLA-MORELOS EARTHQUAKE: SEISMIC EVALUATION

D. Cervantes¹, H. Guerrero¹, J.A. Escobar¹, R. Gómez¹

¹Institute of Engineering, UNAM, México city, México.

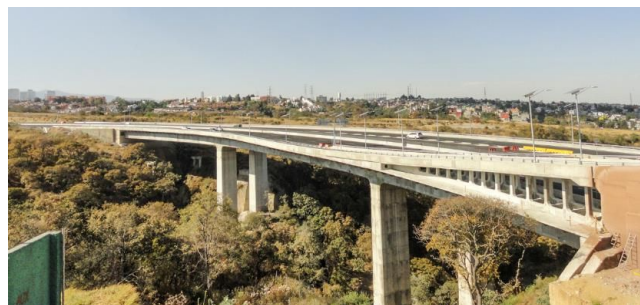
Fig. 1. Vehicular bridge.
