Fire on the New Little Belt Bridge

Niels BITSCH
Project Director
COWI A/S
Kongens Lyngby, Denmark
neb@cowi.dk

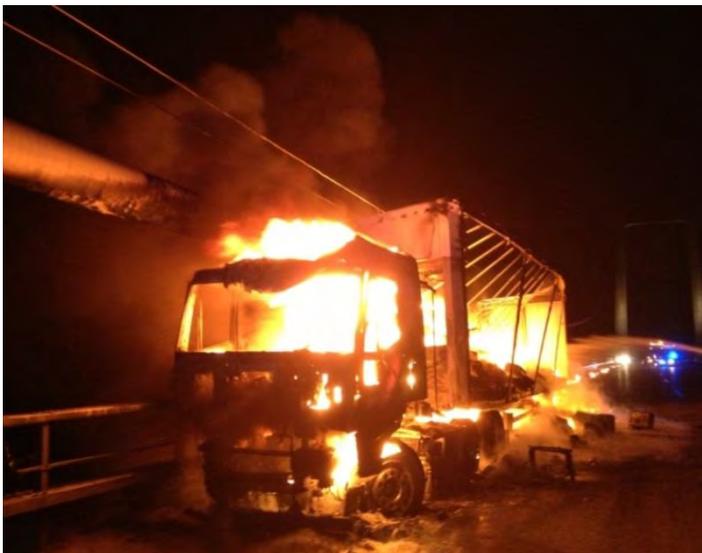
The truck driver parked the heavily burning truck in the emergency lane right beside the lowest point of the main cable and then he called the fire brigade.

Fig. 1: The burning truck right at the main cable
