Collapse of the Koror-Babeldaob Bridge

Summary

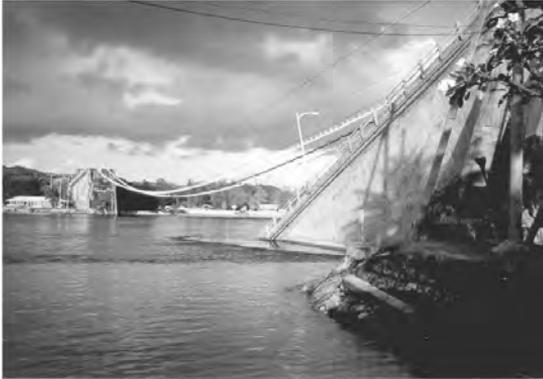
Figure 2. KB Bridge after collapse, March 1997.

The site investigation began six months after the collapse, in March 1997. Figure 2 shows a view of the bridge taken from the Koror side at that time. The investigation team inspected both the above and underwater portions of the structure in three primary areas: 1) the main pier and backspan on the Airai side, 2) the main pier and backspan on the Koror side, and 3) the underwater portion of the main span.
