## Retrofitting of Historical Masonry Buildings in Seismic Zones

## Rehabilitation of a tower structure

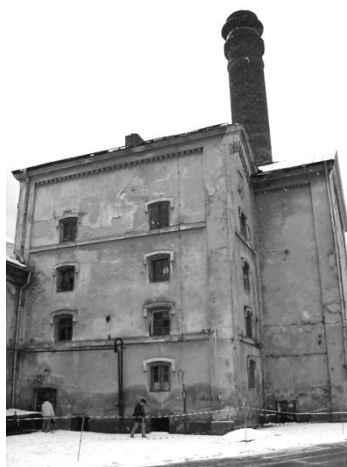
Fig. 1: Old malting building

The old malting building, erected between 1857-1876 at the "Timisoreana" Brewery, is a five storeys masonry structure and a tower (Fig. 1) composed of:

- walls of 140 – 50 cm thickness;
- inter-storey floors - brick masonry vaults supported by steel profiles;
- a tower, of about 14.00 m height and 2.80 m diameter, supported by an interior dome.

codes for existing structures and codes for design loads magnitude. The main structural damages are: vertical cracks in the tower masonry structure; corrosion of steel members: horizontal circular rings for confining the tower; profiles for supporting the floor masonry vaults.

- the tower, about 14 m high, presents general instability at seismic actions: the total bending moment at tower base leads to an eccentricity  $e_0 = 1.78 \text{ m} > D_{ext} / 2 = 1.50 \text{ m}$  where  $D_{ext}$  is the tower exterior diameter;
- in some zones of the tower masonry structure actual stresses, due to various loads, are greater than the tensile strength  $R_{ti}$  of masonry:
  - $\sigma_{ef} = 0.93 \text{ daN/cm}^2 > R_{ti} = 0.8 \text{ daN/cm}^2$  at the tower – dome crossing (50 cm width masonry);
  - $\sigma_{ef} = 3.10 \text{ daN/cm}^2 > R_{ti} = 0.8 \text{ daN/cm}^2$  at the tower base (20 cm width masonry);

- for general stability of masonry tower: vertical reinforcement (Fig. 2) bars (4 x 2 $\phi$ 28) embedded at the upper side of the tower in a RC beam (Fig. 3) and welded on steel profiles I 30 placed in the dome, at the tower base (Fig. 4); vertical CFRP wrap (4 x 2 strips of 20 cm width) on the entire tower height (Fig. 2);
- in masonry structure, at zones with stresses greater than masonry tensile strength, were placed horizontal RC straps: at the tower – dome crossing (Fig. 2); at the base of dome; at the level of steel profiles I 30 network (Fig. 4) for its embedding into vertical masonry structure;
- on the vertical cracked tower: corroded circular steel rings for confining the tower on outside face were replaced by horizontal CFRP strips – Fig. 5.
