## The Chiani Suspension Bridge: A Complete Overhaul

The paper presents the total rehabilitation of the Chiani suspension bridge in Algeria. The bridge, designed by the French engineer Arnodin at the end of the last century span 105 metres using a mixed cable supporting system with a stayed deck portion near the towers. The bridge was designed and built before the similar Sidi M'Cid one in Constantine.

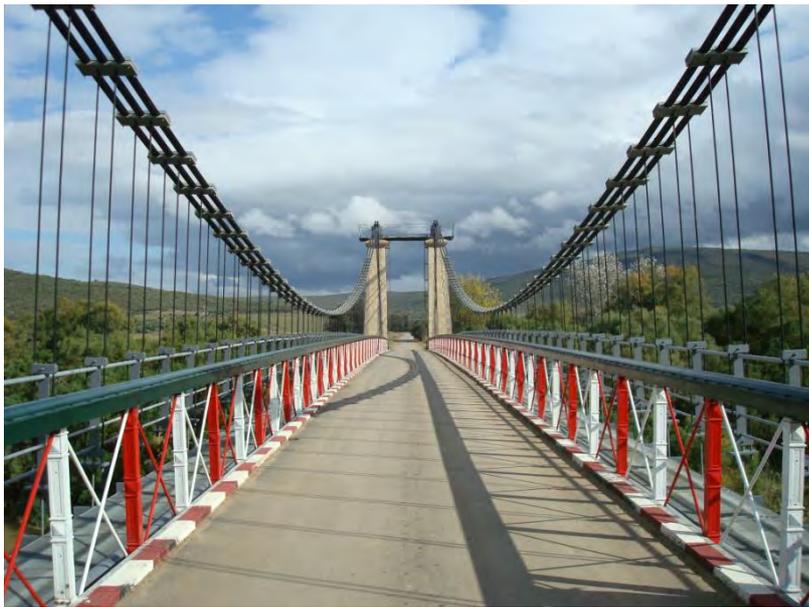
In order to open the bridge to vehicular traffic it was decided to cast a concrete slab on top of the transverse beams in between the two parapet girders. While providing a firm surface for vehicular traffic the slab would also strengthen significantly the bending and axial behaviour of the superstructure. Thickness of the slab has been kept to a minimum (14 cm) so as to reduce its weight. The slab was cast onto corrugated steel sheeting for increased punching and bending resistance. Still, the new concrete slab made for an hundred percent increase of the deck self weight with

respect to the original configuration.

In order to allow for vehicular traffic to run onto the new deck, two other aspects had to be addressed, namely: transverse beams had to be strengthened and kerbs displaced to make place for a single lane carriageway in between the parapet girders. Strengthening of the transverse beams was obtained by welding additional plates onto the bottom flanges and stud connectors on the top ones so as to obtain composite action with the concrete slab.
