Assessment And Restoration Of An Iconic American Baseball Stadium

Summary

In 2006, the authors were retained by the owner to perform a structural assessment of one of the few remaining American baseball stadiums built in the early 1900s. After a thorough condition assessment, it was concluded that the structure was safe, but required remedial work to insure its longevity. Restoration plans were subsequently developed based upon the findings of the condition assessment.

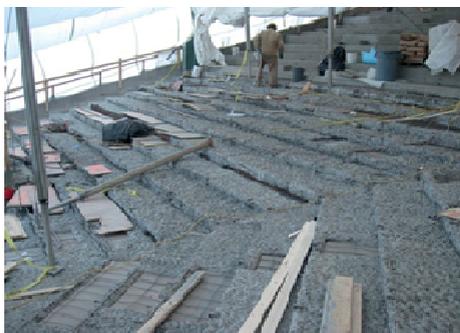
Figure 1. Demolition and surface preparation of seating riser section.

Demolition and surface preparation consisted of shoring the structure, removing the existing riser extensions, and removing deteriorated concrete. Hydro-demolition was used to remove a nominal depth of the exposed riser surface, or to the depth of sound concrete where the exposed riser

concrete was unsound and in poor condition. In some areas, the depth of concrete removal by hydro-demolition extended to the full depth of the structural slab. A section of the right field seating riser after completion of the hydro-demolition is shown in Figure 1.

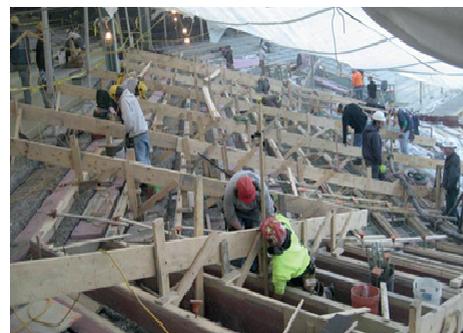
Figure 2. “Flying” form system for overlay.

The objective of the concrete overlay was to replace the existing tread and riser system, and to provide a durable, low maintenance wear surface. The overlay solution was developed so that the weight of the replacement material was equal to or less than the weight of the original material. This was achieved by creating voids with stay-in-place polystyrene where necessary. The durability of the overlay and its effectiveness as a barrier to water infiltration is subject to many variables including the quality of the concrete and jointing of the overlay, which were carefully considered and specified on this project. The contractor utilized a couple different forming methods during the course of the project, but ultimately settled on the “flying” form system shown in Figure 2.
