Remarkable Strengthening of an old Steel Highway Bridge

Keywords: steel bridge strengthening; prestressed tied arch.

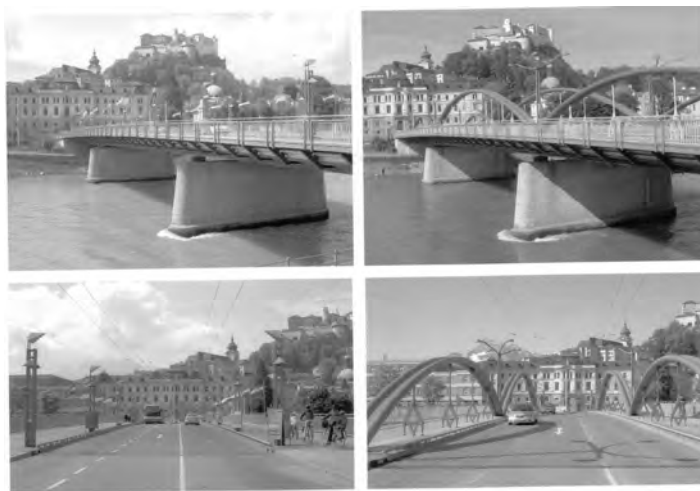
Fig. 1: “Karolinen – bridge” in Salzburg / Austria before (left) and after (right) strengthening

The existing structure called “Karolinen – bridge”, situated within the picturesque Old Town of Salzburg / Austria, is a continuous plate girder bridge with three spans ($L = 30 + 45 + 30$ m) and was completed in 1939 at the beginning of the 2nd world war (Fig. 1). The two main girders, with a distance of 12 m, have a varying depth of 1.1 to 1.45 m (at midspan) and are fully welded.

Based on the three variants the solution with the tied arches was chosen (Fig. 1), also due to aesthetic reasons. The desire for elimination of the bearings results in fixed connections between the arch bases and the old steel girders, shown in detail in the full paper. In order to reduce the axial forces in the old girders sliding plates were used during prestressing. Mentionable is also the design of prestressing (details in the full paper). Although the final prestressing forces in the hangers were nearly the same, the sequence of prestressing - only one pair of tension rods was prestressed by hydraulic jacks at the same time - had to be considered carefully. Only in the last prestressed hangers the actual prestressing force is equal to the final one. Sometimes the actual prestressing force is up to 25 % higher, sometimes up to 30 % less, than in the final condition.
