Replacing a tower at Cape Verdes – Challenges from hard environmental conditions and a modular concept

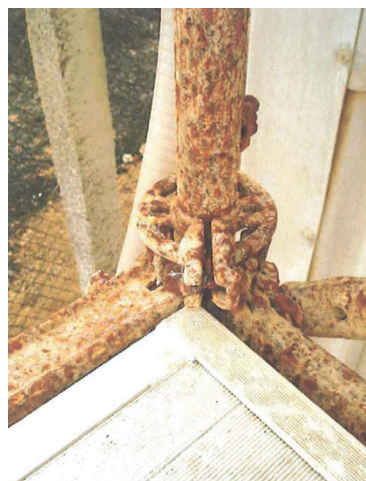
Fig. 1: Deterioration of existing structure with corroded pipes and connectors (detail)

Due to the described environmental conditions the steel structure heavily deteriorated by corrosion already in a very short time. The deterioration shown exemplarily in figure 1 already appeared after 27 months of use. The picture is taken in late 2008. Especially the pipes and the connectors of the pipe rack had been affected by extensive and widespread corrosion.

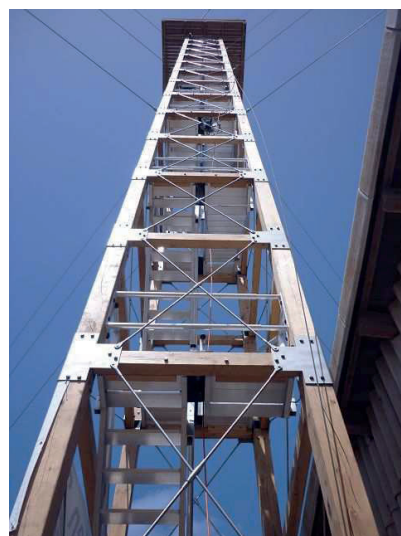
Fig. 3: Replacement structure at final position

To conclude, a sustainable structure could be achieved by using suitable materials, highly sophisticated engineering and experienced and well-skilled manpower for work preparation in Germany and on site at Cape Verdes. According to the authors' opinion the tower also fulfils architectural requirements of a well designed and created piece of building (see figure 3).
