## Spreading suspension cable at the Rhinebridge Emmerich, Germany

### Abstract

The Rhinebridge Emmerich of 1962 is a suspension bridge, with two 77 m high steel pylons, and 500 m long. The suspending cables consist of 61 parallel locked coil strands. The hangers are fixed to the suspension package by an iron cast saddle-clamp each. Corrosion products had spilled from the inside of the suspension cable at the lowest point. In order to investigate the corrosion of the cable in the interior, the suspension cable was opened under terms of running traffic using a special device with grippers. As a result, the strands of the cable could have been inspected all around. It was found, that the more than 50 years old strands are in very good condition. After documentation the strands have been cleaned, coated and lead back into the suspension package. The old saddle-clamp was fixed again and suspension cables were replaced.

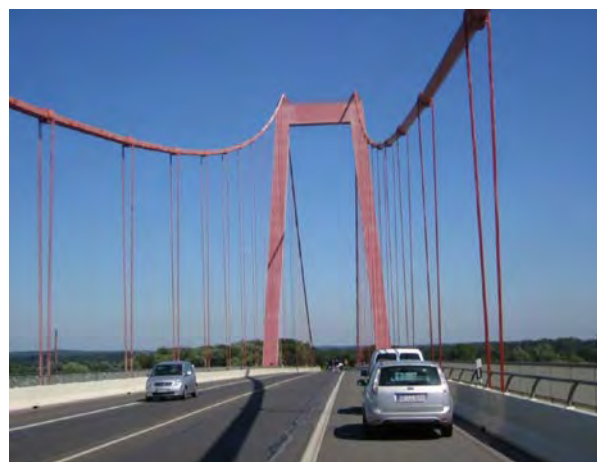
Figure 1: The Rhinebridge Emmerich

The suspension cables consist of 61 locked coil strands of 51.8 mm diameter, which are arranged hexagonally and are protected by a cast PUR sheath. The 104 hangers are made of locked coil strands of 34 and 42 mm in diameter, each of which are double guided about cast iron cable clamps.
