Veterans Home Bridge Rehabilitation

Eduardo Arellano P.Eng., Kip Skabar PE P.Eng., Yuki Kishimoto EIT

Stantec Consulting Ltd., Burnaby, BC, Canada

Bridge rehabilitation projects are completed to permit current design loads and State legal loads on existing structures. This paper presents a rehabilitation case study of the Veterans Home Bridge, a historic orthotropic steel deck arch structure that was constructed with distinctive aesthetics and in an era that warrants its listing in the National Register of Historic Places (NRHP) as a contributing element to the Minnesota Soldiers' Home Historic District. Following a fracture critical inspection which identified critical deficiencies that required urgent repairs, a load rating analysis was completed for the steel truss, which resulted in a 12 Ton Gross Vehicle Weight (G.V.W.) load posting requirement. Because minimum emergency vehicle G.V.W.s exceed this load restriction, the bridge was closed to the public. Multiple repair options were evaluated and a detailed rehabilitation design was completed to facilitate American Association of State Highway Officials (AASHTO) HS-20 Design Truck loading and to meet the aesthetic requirement

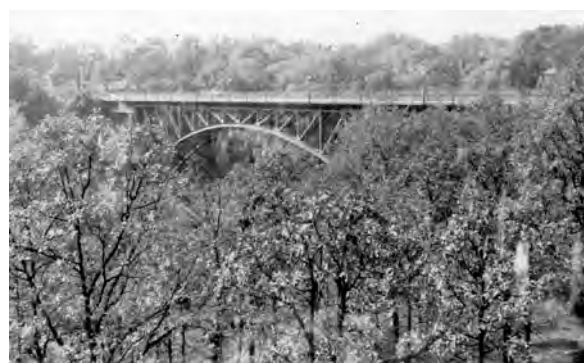
Figure 1. Veterans Home Bridge ^[1]

The Veterans Home Bridge (Figure 1), formerly known as the Old Soldiers Home Bridge, is located downstream of Minnehaha Falls in Minneapolis, Minnesota. The bridge was constructed in 1908 for the Minneapolis Board of Park Commissioners to carry vehicular traffic over Minnehaha Creek to the Minnesota Soldiers' Home (now the Minneapolis Veterans Home) from Minnehaha Park.
