Contributing human and organizational factors for the collapse of a temporary supporting structure for the B-tower in Rotterdam

Abstract

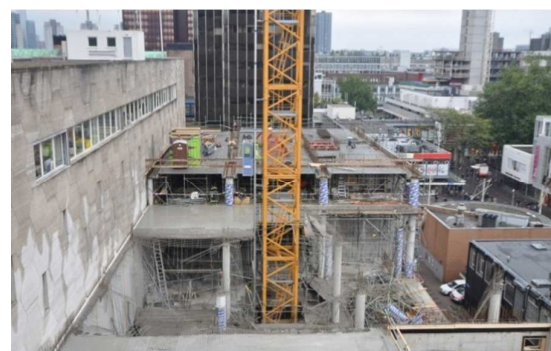
Fig. 1: Top view of the collapsed structure (photo: Karel Terwel)

Investigation from the Dutch Safety Board revealed that a large number of stability braces was omitted in one direction, resulting in instability and collapse of the temporary structure. This omission had been noticed, but because of unclarity in responsibilities no follow up was given to this warning.
