# AESTHETIC AND HISTORICAL ASPECTS OF REPAIRING THE "PANCERA" FLYOVER IN WARSAW

W. Trochymiak<sup>1</sup>, K. Bucholc<sup>1</sup>

<sup>1</sup>Warsaw University of Technology, Faculty of Civil Engineering, Warsaw, Poland.

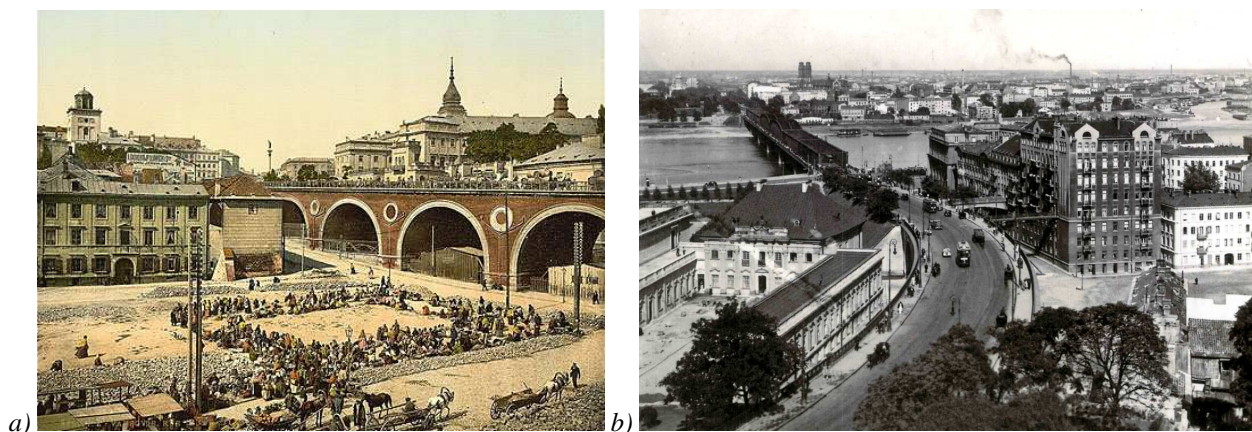
**Fig. 1.** *Feliks Pancer Flyover from before World War II; a) southern facade, facing the Royal Castle [11]; b) top view with the access road to Kierbedź Bridge.*

Warsaw's Feliks Pancer flyover (named after Feliks Pancer, a prominent Polish engineer (1798-1851)), which is characterized by a monumental, arched brick structure, having the overall length of 657 meters, was built in the years 1844-1846 (Fig. 1). It enabled access, from Krakowskie Przedmieście Street's level to a boat bridge constructed at the extension of Bednarska Street and subsequently, from 1864 to Kierbedź Bridge (the presentation will contain additional information regarding location of the flyover). During World War II Warsaw, and in particular some of its parts, such as the Old Town, were demolished or significantly damaged (Fig. 2). All of Warsaw's bridges spanning across the Vistula River, and a significant part of the urban infrastructure, were also destroyed or damaged. The Feliks Pancer flyover was partly destroyed in 1944 (Fig. 3), and during the construction of Wschód-Zachód (East-West) Route (the W-Z Route for short) it
