## THE REFURBISHMENT OF THE LLANGOLLEN CHAINBRIDGE

### Summary

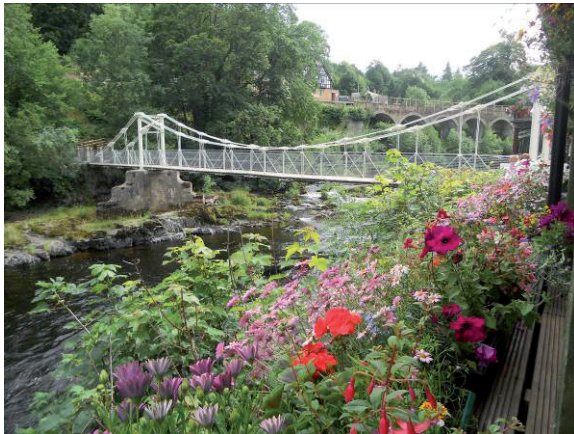
*Fig. 1. Complete Bridge viewed from downstream on the Hotel North Bank*

The Llangollen Chainbridge crosses the River Dee approximately 2km north west of Llangollen, North Wales. A bridge has existed in this location since 1817 but the structure had fallen into disrepair resulting in its closure in the mid 1980's. In 2009 the Chainbridge was included in the World Heritage Site of Pontcysyllte Aqueduct and Canal. Llangollen Town Council appointment Ramboll assess the existing structure and determine the required restoration works (Figure 1).

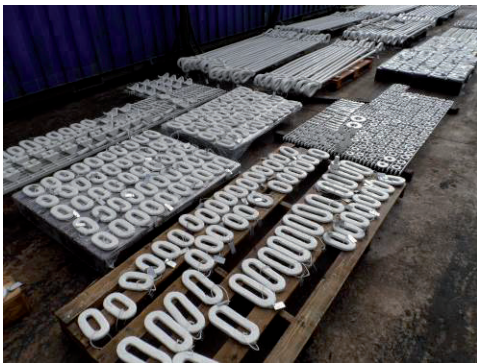
Fig. 3. Dismantled bridge elements labelled and painted in workshop

The condition of each element was inspected following dismantling. Where the corrosion of the wrought iron elements was excessive or where they were beyond repair, new identical elements were fabricated from mild steel. The stanchions and anchor points were refurbished insitu. Once the metal elements were restored the bridge was reassembled and each element returned to its original position. Those elements that were deemed too corroded to be repaired were sent to the local Museum in Llangollen and replacement elements were forged from mild steel. All the bridges elements, old and new received a flexiblised epoxy paint system. Refurbishment works were designed so that the appearance of the bridge was as close to that of the 1928 structure as possible taking into account the requirements of modern safety standards.

The works involved restoring and repairing each iron element, providing a new timber deck and new handrail system. The bridge is thought to comprise some of the oldest wrought iron still in use requiring careful construction techniques and traditional methods for the works to preserve as much of the existing wrought iron elements as possible. Each metal element was labelled, the bridge dismantled, transported to the workshop by the local Welsh Highland Steam Railway and the metal elements stripped back to the parent material and recoated with a paint system in workshop conditions.

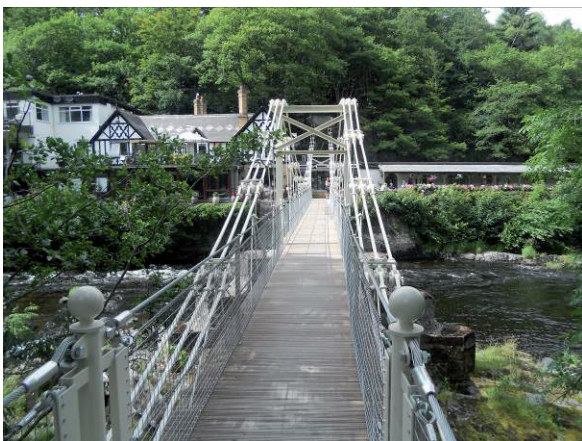
Fig. 3 Complete Bridge viewed from the south bank
