THE REFURBISHMENT OF THE LLANGOLLEN CHAINBRIDGE

Summary

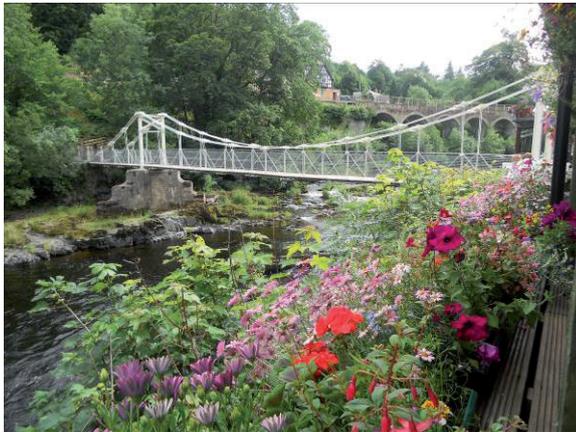
Fig. 1. Complete Bridge viewed from downstream on the Hotel North Bank

The Llangollen Chainbridge crosses the River Dee approximately 2km north west of Llangollen, North Wales. A bridge has existed in this location since 1817 but the structure had fallen into disrepair resulting in its closure in the mid 1980's. In 2009 the Chainbridge was included in the World Heritage Site of Pontcysyllte Aqueduct and Canal. Llangollen Town Council appointment Ramboll assess the existing structure and determine the required restoration works (Figure 1).

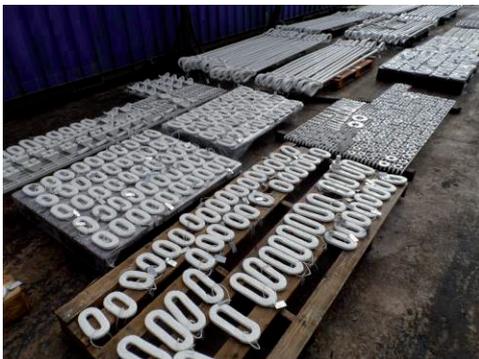
Fig. 3. Dismantled bridge elements labelled and painted in workshop

The condition of each element was inspected following dismantling. Where the corrosion of the wrought iron elements was excessive or where they were beyond repair, new identical elements were fabricated from mild steel. The stanchions and anchor points were refurbished insitu. Once the metal elements were restored the bridge was reassembled and each element returned to its original position. Those elements that were deemed too corroded to be repaired were sent to the local Museum in Llangollen and replacement elements were forged from mild steel. All the bridges elements, old and new received a flexiblised epoxy paint system. Refurbishment works were designed so that the appearance of the bridge was as close to that of the 1928 structure as possible taking into account the requirements of modern safety standards.

The works involved restoring and repairing each iron element, providing a new timber deck and new handrail system. The bridge is thought to comprise some of the oldest wrought iron still in use requiring careful construction techniques and traditional methods for the works to preserve as much of the existing wrought iron elements as possible. Each metal element was labelled, the bridge dismantled, transported to the workshop by the local Welsh Highland Steam Railway and the metal elements stripped back to the parent material and recoated with a paint system in workshop conditions.

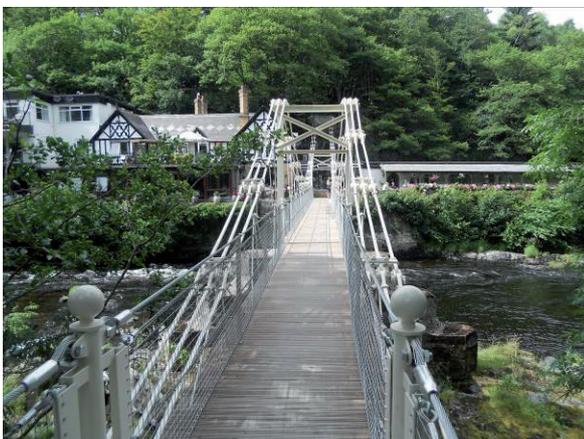
Fig. 3 Complete Bridge viewed from the south bank
