## The rehabilitation of long span truss bridge

The rehabilitation works on the five span continuous Warren type steel truss bridge built in 1961 have been presented in the paper. Because of steel structure deterioration and huge live loads growth during recent years, the bridge has been selected for the comprehensive rehabilitation with a main goal to increase its load carrying capacity. Apart from the strengthening of truss girders (f.e. member sections enlargement, external prestressing, rivet replacement, etc.), the rehabilitation also included deck grid extension, redecking of deteriorated concrete slab and upgrading of supports. The repair program for existing steel structure contained among others the replacement of two diagonals deformed by impact of vehicles. The rehabilitation procedure has been presented in the paper as well as the proof load test results, which proved rehabilitation efficiency.

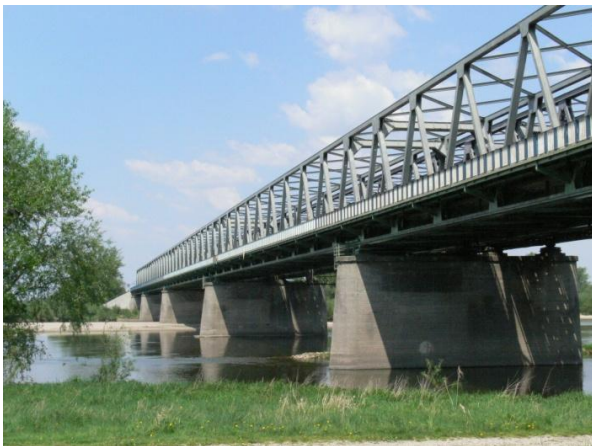
The bridge over Vistula river in Nagnajow is five span continuous Warren type steel truss with RC deck slab (Fig.1). The spans of steel truss are 72+3x90+72 m long. The bridge has been selected for the comprehensive rehabilitation with a main goal to increase its load carrying capacity. Before the design work has begun, the comprehensive assessment of the bridge state of repair along with load carrying capacity evaluation (with the proof test) were undertaken in order to find the most relevant methods for bridge rehabilitation. The most severe faults discovered during assessment were mechanical damages (plastic deformations) due to vehicle collision with bridge diagonals, cracks in one floor beam over a support and loss of member sections due to intensive corrosion after 50 years of service.

*Fig. 1: The truss bridge before rehabilitation*
