Using an ambient vibration test to identify damage in a sculpture

Elsa Caetano

Faculty of Engineering of the University of Porto, Porto, Portugal

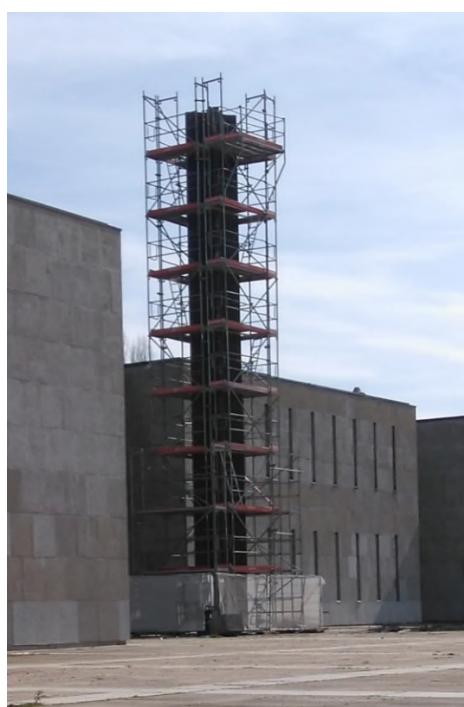
Figure 1. The Obelisk, general view

The study focuses on a sculpture located at the campus of the Porto School of Economics, in Portugal. The sculpture structure is an obelisk, a pillar made of reinforced concrete with a height of 18.5 m above the ground, with an "X"-shaped cross-section covered by brass plates (Figure 1). The observation of a partial detachment of the brass cladding due to the corrosion of the reinforcement (Figure 2) motivated the conception of a conservation and rehabilitation project by the Owner of the structure [1]. This project included the removal of the brass cladding, the repair of reinforced concrete and the application of a new brass cladding. However, upon the starting of dismantling the brass plates, relevant vibrations were observed. The fear regarding the potential existence of severe damage along the pillar of the reinforced concrete structure underneath the brass cladding motivated the study here described, which included the development of a numerical model and the corresponding calibration based on an ambient vibration test. The paper describes the
