## BURGOYNE BRIDGE DESIGNED TO RESPECT HISTORY OF SITE AND TO CREATE A NEW LANDMARK

### Summary

The Region of Niagara is in the process of replacing the nearly 100-year-old Burgoyne Bridge in the City of St. Catharines, Ontario, Canada. Two key factors were the desire to create an iconic or landmark bridge, and the necessity of maintaining traffic throughout construction. The paper discusses technical considerations including corridor selection, alignment, staging, detailed geometry, the integration of bridge construction and bridge demolition, the consideration of adjacent properties and businesses, and connections to local roadways. The development of the new bridge concept and preliminary design are also explored, including reference to inspirational projects elsewhere, and to the history of heritage bridges at the site. Finally the resulting 330m long twin structural steel box girder viaduct bridge, including a single 125m structural steel arch span, is put into context from technical, environmental, and stakeholder perspectives.

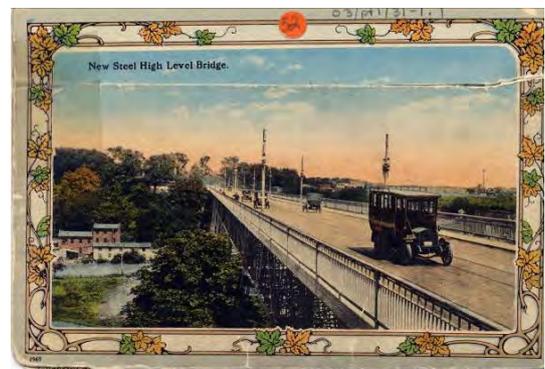
*Fig. 1: Existing high level steel truss*

For the past nearly 100 years the Burgoyne Bridge in the City of St. Catharines has served as a key link in the transportation system of the City and of the Region of Niagara. The existing bridge is the most recent in a series of bridges constructed at the site since the inception of the City of St. Catharines in the mid-1800s. It forms a major element of the City infrastructure.

The bridge was judged, following detailed inspection, maintenance, analysis, and monitoring over a period of time, to be reaching the end of its useful life and to require replacement by a new crossing.
