Evaluation of the remaining lifetime of the piers of the railway bridge crossing the Little Belt, Denmark

Summary

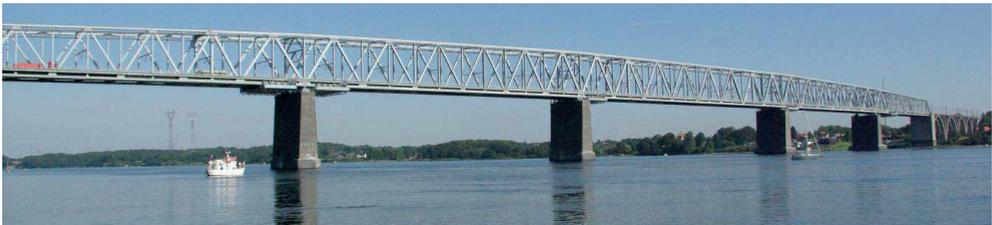
Fig. 1: Overview of the railway bridge across Little Belt, the only railway link between the western and the eastern part of Denmark. The 4 main piers are situated in seawater, 60 m from the seabed.
