Collapse of the Koror-Babeldaob Bridge

Summary

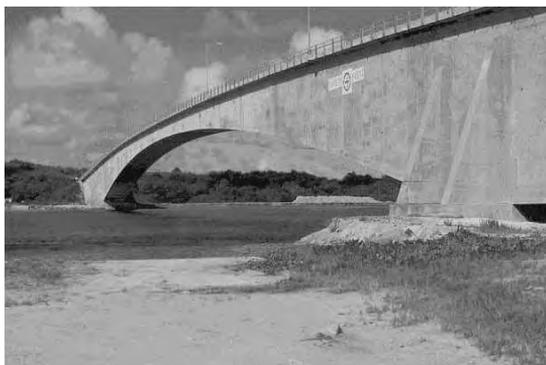
Figure 1. KB Bridge shortly after construction, circa 1980.

The Koror-Babeldaob (KB) Bridge connected the islands of Koror and Babeldaob (a.k.a. Airai) in the Republic of Palau. When completed in April 1977, the 241 meter main span of the KB Bridge was the longest concrete box girder span in the world. A photograph of the bridge taken shortly after construction is shown in Figure 1.
