Assessing and Rehabilitating the Anthony Wayne Suspension Bridge

The Anthony Wayne Suspension Bridge Assessment & Rehabilitation project is located on U.S. Route 2 in Toledo, Ohio. Built in 1931, the bridge is in need of rehabilitation and repair to extend its life. An inspection and analysis of the suspension spans, deck truss and girder approach were performed prior to rehabilitation design to determine appropriate repair measures. The rehabilitation and repair measures include: concrete deck replacement; cable opening and inspection, structural steel repairs; deck truss span replacement; and deck joint elimination.

This project is the rehabilitation of the Anthony Wayne Bridge, a major high-level bridge on U.S. Route 2 that spans the Maumee River in Toledo, Ohio.

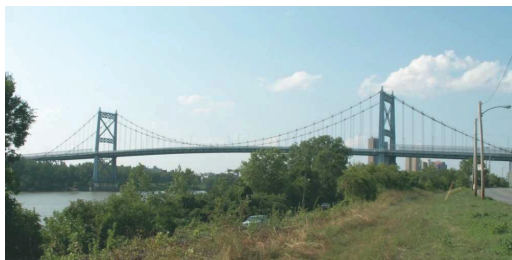
Fig. 1: Anthony Wayne Suspension Bridge

The bridge is comprised of 28 spans, extending a total length of 980 m and includes: nine multi-beam spans; 14 two girder spans; 2 deck truss spans; and the suspension spans. The roadway has two lanes in each direction with a width of 7,9 m measured from sidewalk curb-to-toe of 685 mm median barrier for an overall curb-to-curb dimension of approximately 16,45 m. Each sidewalk extends 2,0 m from toe of curb to outside edge. Previous significant rehabilitations have been performed to the bridge in 1961 and 1996.

The suspension spans are comprised of two steel stiffening girders, floorbeams, and stringers supporting a reinforced-concrete deck. Side span lengths are 71 m spans, with a main span of 239 m. The steel deck trusses, floorbeams, and stringers support a reinforced concrete deck at the ends of the suspension spans and are 58,5 m in length. The two girder spans are made up of riveted plate girders with floorbeams and stringers that support the reinforced-concrete deck at each end of the bridge. Span lengths vary from 21 m to 50,3 m. The multi-beam spans consist of steel rolled beams that support the reinforced concrete deck. Span lengths vary from 6,1 m to 13,8 m.
