DESIGN AND VIBRATION SERVICEABILITY EVALUATION OF PEDESTRIAN SPACE ARCH BRIDGE

Wirye bridge with a width of 7.3m and an extension of 109m is a pedestrian space arch bridge crossing the highway of 70m width. Due to the on-site conditions of crossing a highway with high traffic volume, steel pipe girder and steel deck was installed by small-block erection method after erecting arch rib and vertical members with single lift installation method. It is possible to mount the steel pipe girder and the steel deck more easily by installing a cross beam in advance that connects the vertical members each other to reduce the deformation of the vertical member. And the cross beam can improve the structural safety of the buckling through the decrease of the unsupported length by the vertical member acting as both-end supported conditions instead of cantilever during construction period. As a result of the serviceability evaluation for deflection and vibration, it was presented that Wirye bridge satisfied with serviceability criteria for deflection and vibration. In addition, vibration comfort evaluation according to ISO 2631-2 verified that the exposure time of fatigue-decreased proficiency bou

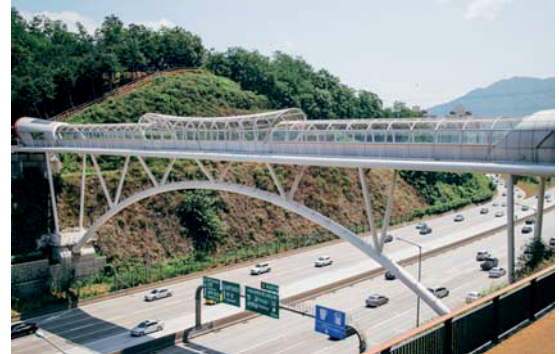
Fig. 1. Wirye bridge, a) Longitudinal section, b) Completed structure

Wirye bridge is a space arch bridge that crosses the highway. The plane alignment is straight and the vertical alignment slope is 5%. The total span is 109m and the vertical is 15m+14.5m+4@12.5m+14.5m+15m spacing. The overall width including the maintenance passage is 7.3m.

For the bridge construction, a erection bent was installed in a place where it would not interfere with highway traffic. The bridge members were divided into 9 blocks and constructed using 550ton and 250ton crawler cranes. The construction of the bridge was planned that the arch ribs and vertical members were installed and then the steel pipe girders were erected on the vertical members. In this case, it is possible to mount the steel pipe girder and the steel deck more easily by installing a cross beam in advance that connects the vertical members each other to reduce the deformation of the vertical member. And the cross beam can improve the structural safety of the buckling through the decrease of the unsupported length by the vertical member acting as both-end supported conditions instead of cantilever during construction period.
