Post Tsunami Reconstruction in Indonesia

Robert MAGLIOLA Senior Project Manager Parsons Corporation Chicago, IL, USA Magliola@att.net

Summary

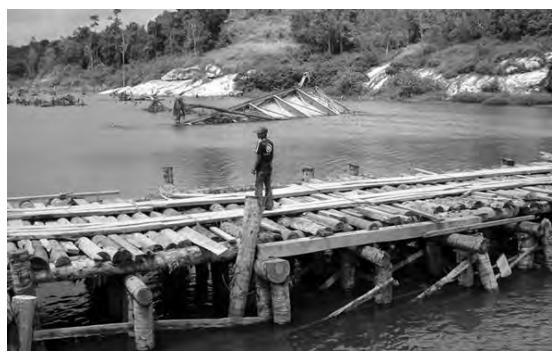
Fig. 1: Post-tsunami Emergency Bridge January 2006

At some waterways temporary panel bridges had been constructed. These were holding up well for the most part except for the timber decks that were becoming worn and had occasional missing planks. Other bridges seemed to be of local design and construction from materials that could be obtained locally. Many bridges were made of tree trunks and logs. The nicer variety of these had timber plank decks. The photo in Figure 1 shows a log bridge with planks positioned to align with vehicle wheels. In the water is the bottom side of a truss bridge that was destroyed by the tsunami.

A year after the tsunami we drove the 240 km coast highway between Meulaboh and Banda Aceh and observed first hand the emergency bridge constructions. At some waterways temporary panel

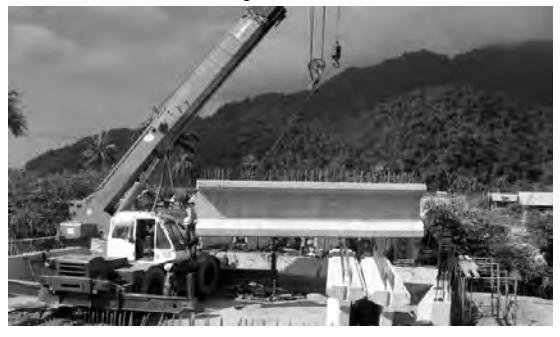
Fig. 2: Precast Segment About to be Launched

Due to shipping constraints and to facilitate erection, precast concrete Ibeams were fabricated in approximately 6 m long segments. At the bridge site, segments are assembled and post-tensioned into a continuous beam. Epoxy is applied to the keyed mating surfaces prior to post-tensioning. The preferred erection method is to launch the individual girder segments across temporary supports. They are posttensioned after the segments are in position from one bridge pier to another.

The Indonesian MPW requested that the maximum concrete I-girder length be limited to 33 m.
