# Replacing of a steel bridge by rotation around the longitudinal axis

Dolejš Jakub, Drábek Vojtěch, Kolpaský Ludvík, Werunský Martin, Červenka Petr, Příbramský Vladimír, Ryjáček Pavel

Czech technical university in Prague, Faculty of Civil Engineering. Czech Republic.

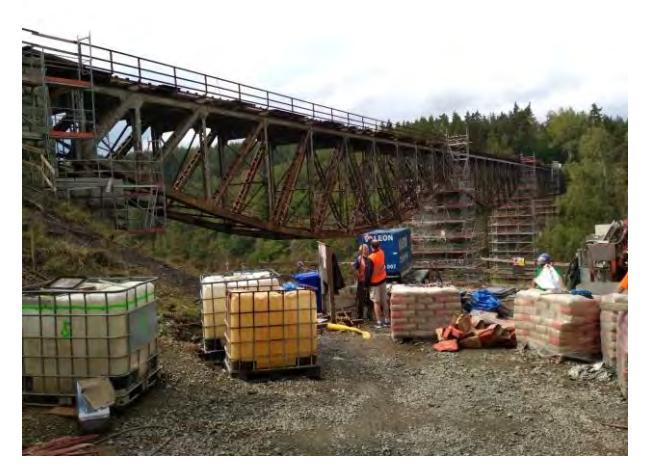
The original bridge was over 100 years old, also was badly damaged by corrosion. That was the main reason for replacing it with a new one. (Fig. 1). The bridge had five spans. The outer spans were formed by stone arches. The three main steel spans were identical with a length of 57m. The riveted steel truss had a curved lower chord with an uplift around 6 m (the whole height of the bridge was around 10m). The bridge had an open-top deck with timber bridge ties. The deep Hracholusky valley was spanned thanks to a pair of stone piers about 46m high. On the banks of the valley were stone abutments that were adjacent to the outer arched spans.

Figure 1. – The view on the bridge in the Hracholusky valley, at the start of the reconstruction [1]
