THE JOHN V. TUNNEY BRIDGE: A NEW COURTYARD CONNECTION FOR THE HAMMER MUSEUM

Summary

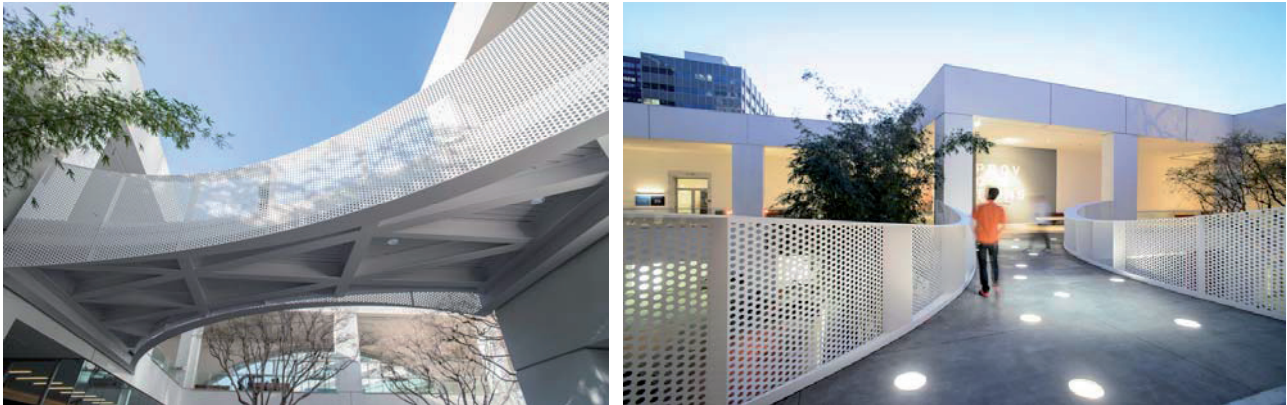
Fig. 1. and 2. The John V Tunney Bridge at the Hammer Museum (Photos by MMA)

The bridge design takes advantage of the geometry of the existing courtyard, and uses curved members both in plan and in elevation to hug the existing rectilinear building smoothly, creating a seamless connection between galleries. The primary steel structure, which is exposed, consists of steel wide flange beams supporting a slab on deck. Seen from below it appears to hover above the courtyard on invisible supports. The bridge's contemporary architectural expression provides a highly-refined pedestrian connection that compliments the original building's aesthetic and creates an exciting focal point for the museum.
